ASBESTOS AND LEAD-BASED PAINT INSPECTION REPORT

LEUZINGER HIGH SCHOOL

CENTINELA VALLEY UNION HIGH SCHOOL DISTRICT

APRIL 2010

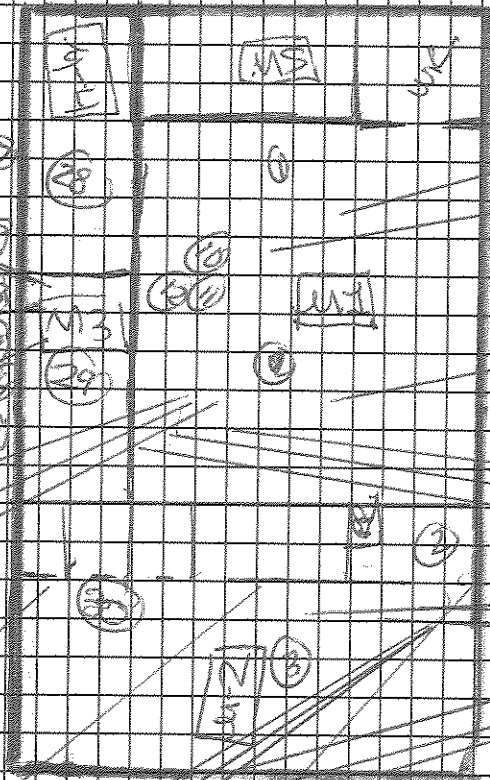
DESCRIPTION: BWD 23 dm sample locations
JOB NAME: Loucinger HS
JOB NUMBER: P100 TACT
DRAWN BY: Francisco Barrera DATE: 4

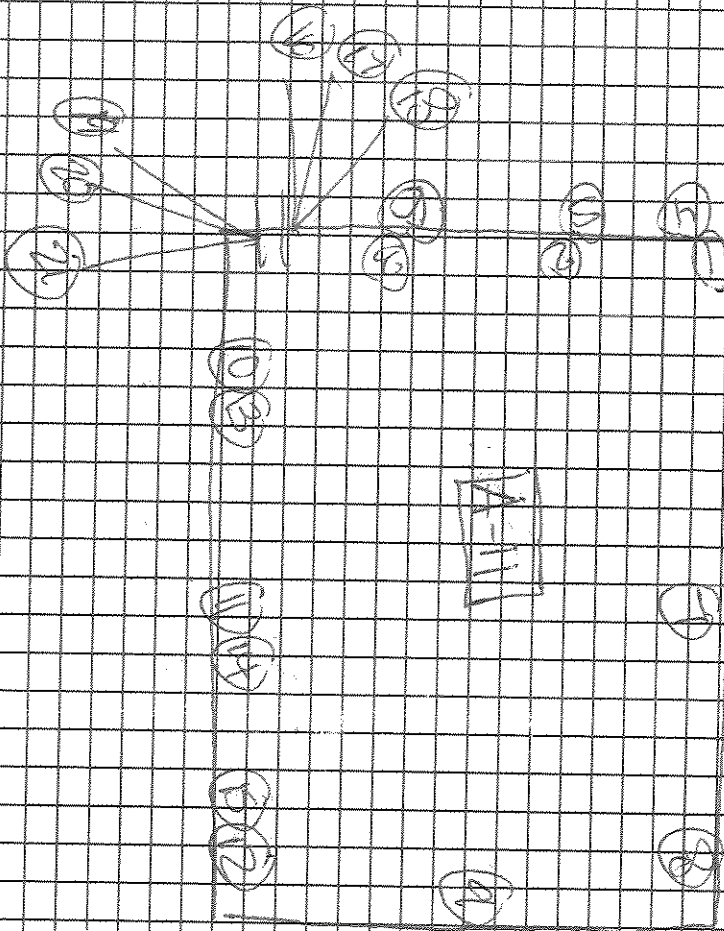
DESCRIPTION: A-11-PIM

48 FLTS
2 mercury
8 lbs Green
2 lbs
pebbles

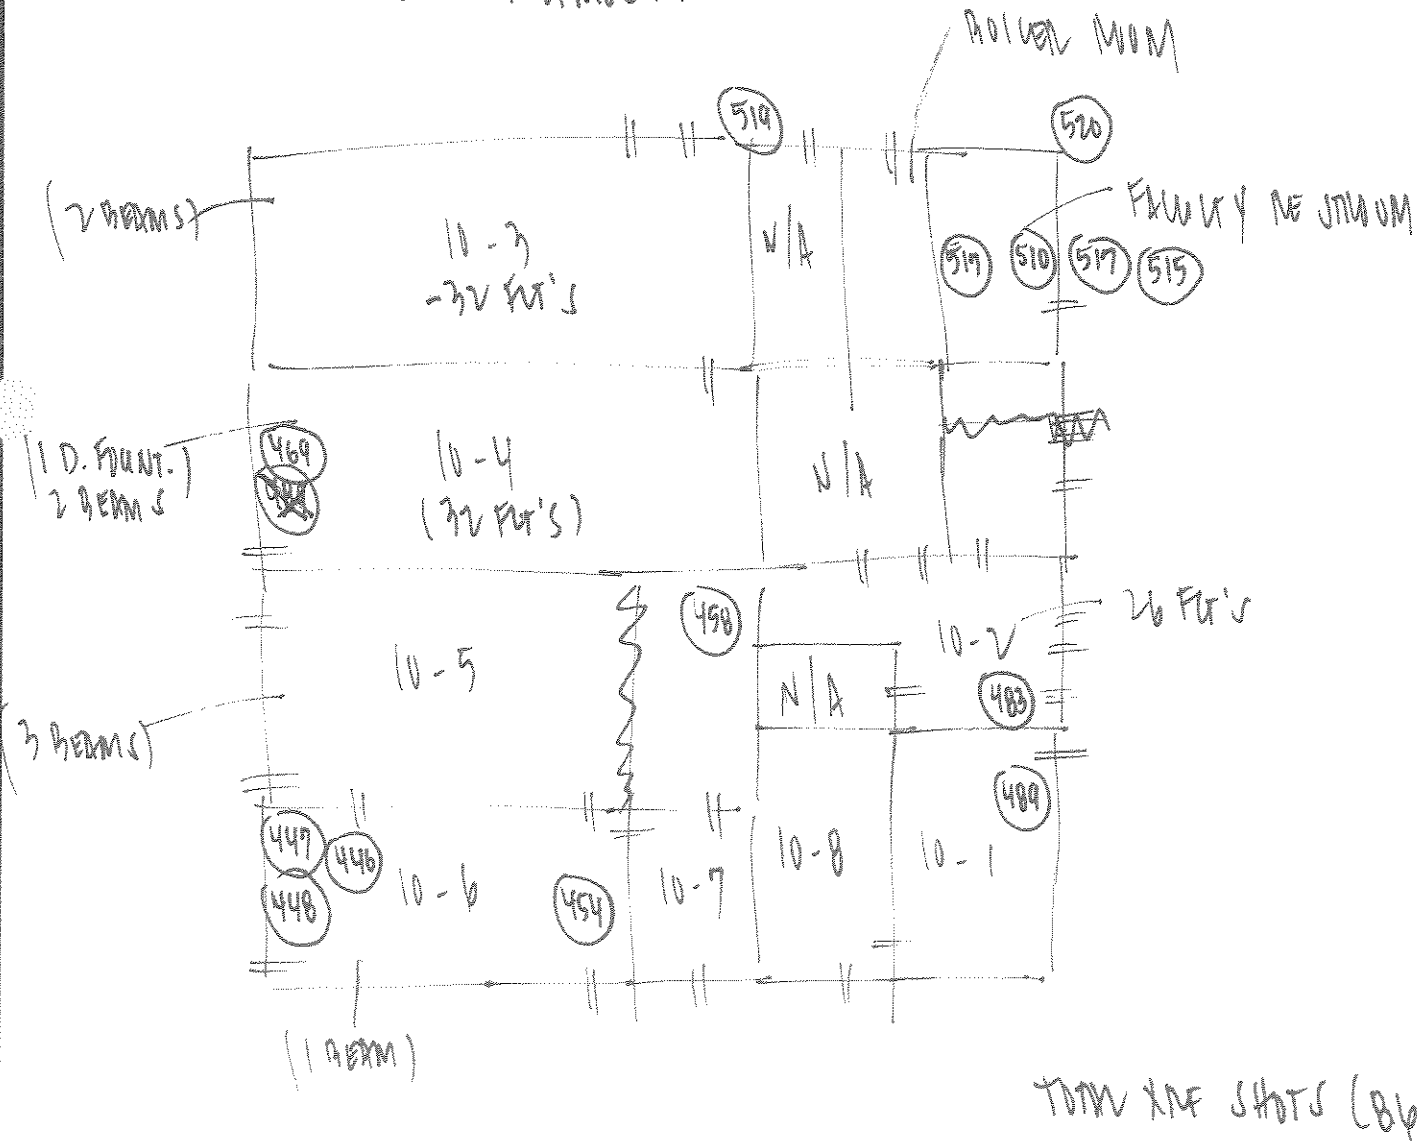
★ 300 FUR'S
★ 10 THERMOSTATS

DESCRIPTION: BUILDING 10
 JOB NAME: CUCSD - WENZINGER H-15
 JOB NUMBER: 120097-019
 DRAWN BY: M. THOMPSON DATE: 4 / 5 / 10

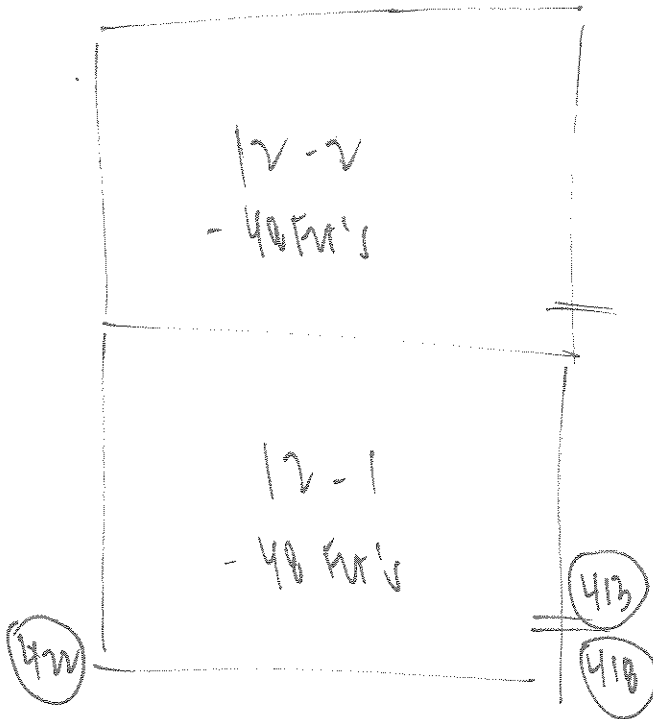
BUILDING 12

± 96 fur's

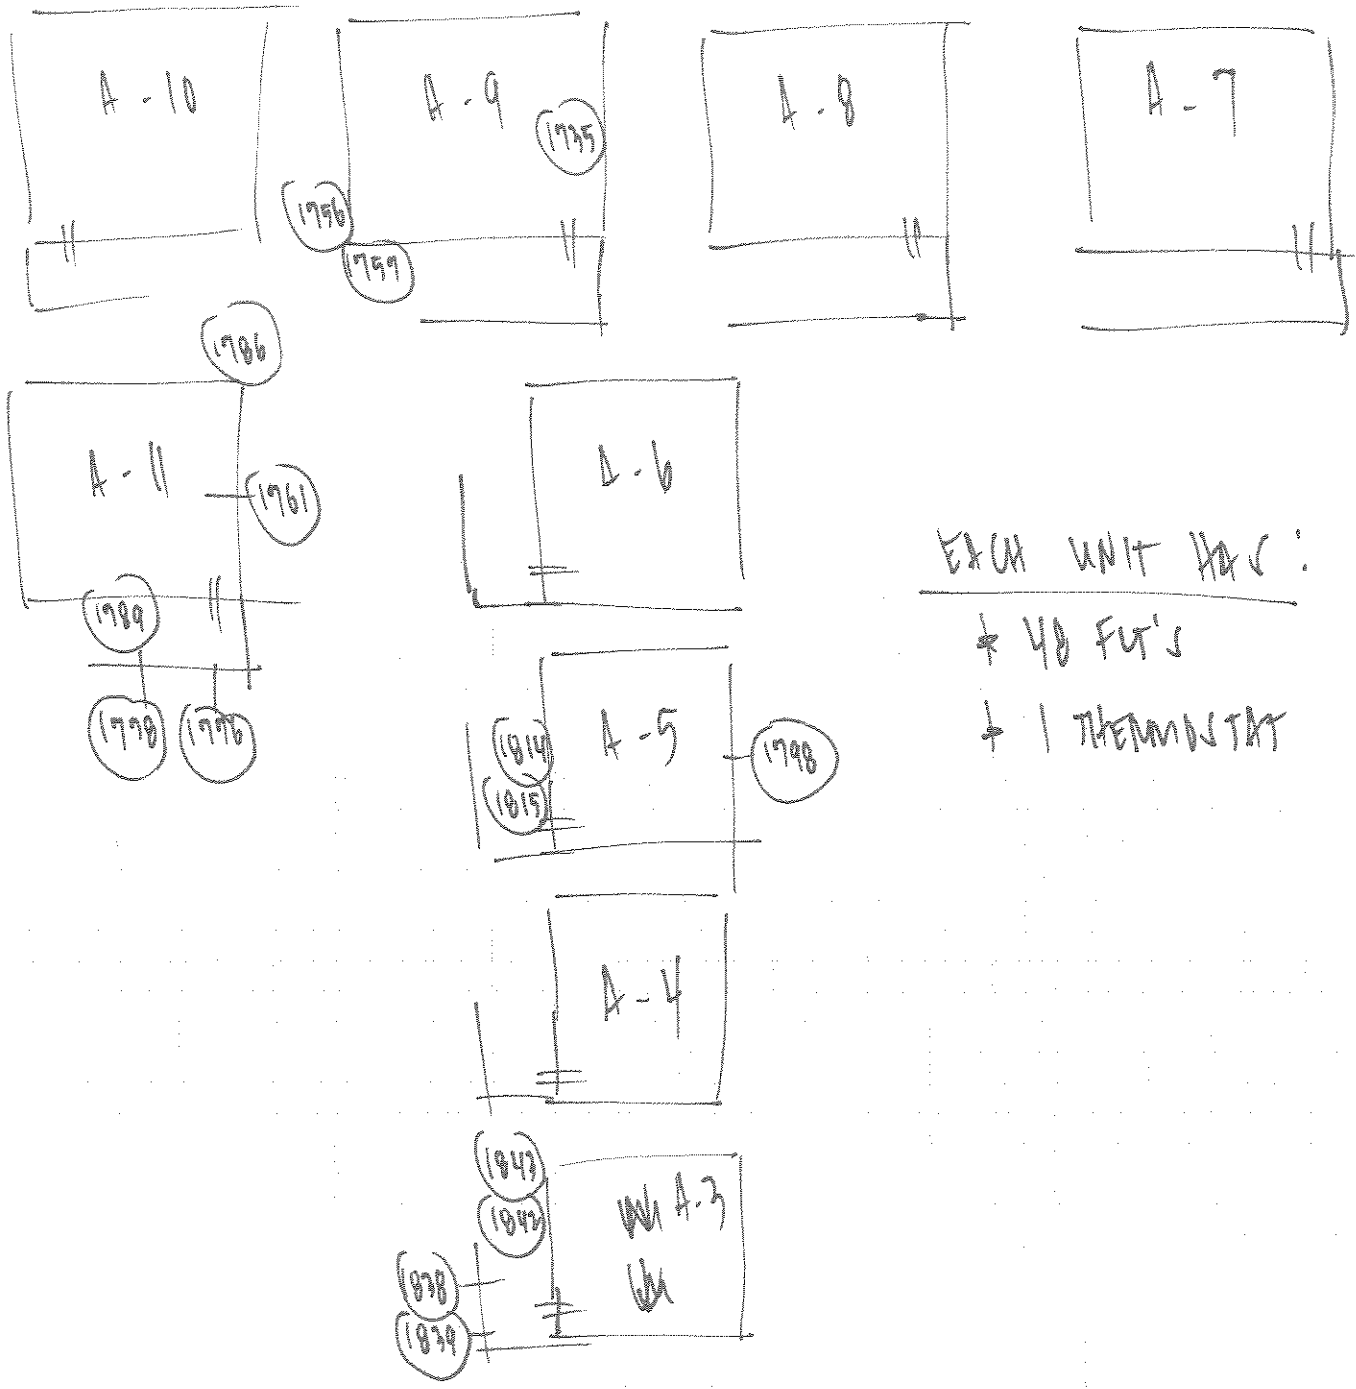
EXCH UNIT HAS:
 * 48 FUR'S
 * 1 THERMOSTAT

TOTAL XRF SHOTS (114)
